National Exams May 2011

07-Bld-A7, Building Envelope Design

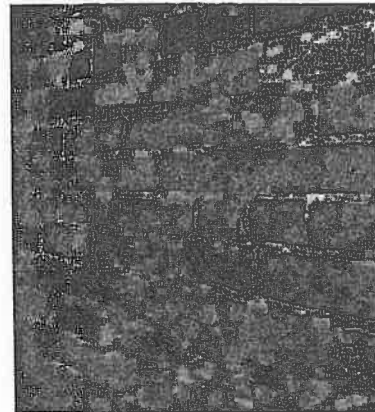
Figure b) shows the interior surface of a solid brick wall in a three-story single-family house. Please note the white deposition on the interior surface of brick, especially at the mortar. What is it and what could have possibly caused it and how to correct the problem?

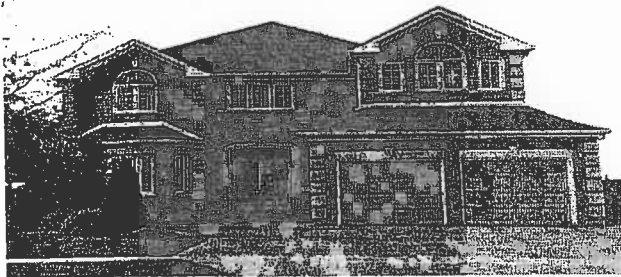
Design and detail a pitched residential roof system for the house shown in the photo below. The house is located in the Greater Toronto Area. Ontario Building Code requires a roof assembly with a RSI 7.0. Attic ventilation is required.
