National Exams Dec. 2012

07-Bld-A7, Building Envelope Design

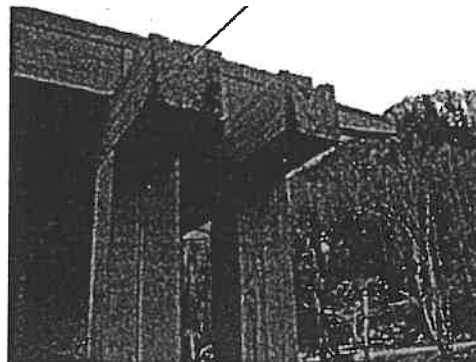
Photo 2

As shown in photo 2, the end section of a wooden beam experienced serious deterioration. 1) Explain the cause and mechanism that led to this deterioration. 2) what should have been done to prevent this?
