National Exams Dec. 2012

07-Bld-A7, Building Envelope Design

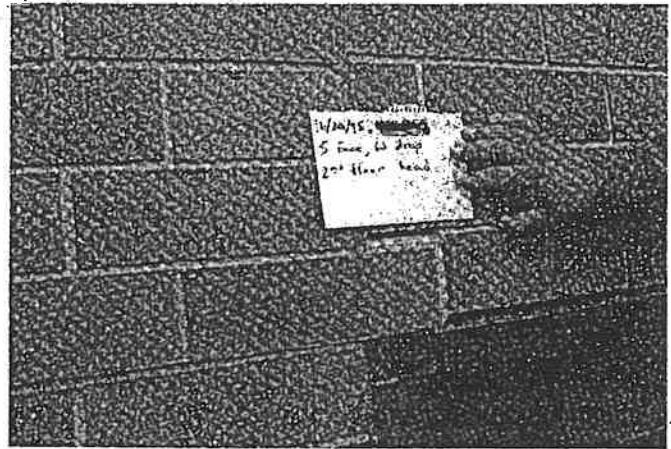
The 24-story tower was constructed in 1983 and, shortly after being occupied, suffered severe distress in the exterior brick masonry veneer. The timing and accumulation of distress toward the bottom of the tower as shown in the photo are both characteristic manifestations of the failure mechanism: frame shortening.

The majority of the strain occurs early in the life of the structure.

When constructed, the masonry was fully seated on the shelf angles, and the courses were in alignment. Tremendous in-plane forces have distorted the steel angles and translated the prism of masonry downward to the left of the expansion joint, leaving the masonry to the right behind. Other distress included spalled and cracked brick units, stair-step cracks through the masonry, and out-of-plane displacement and rotation of entire masonry panels.
